9 ELEMENT

WATERSHED MANAGEMENT PLAN

FALL
UPDATE
2014

UGA CAMPUS STREAMS

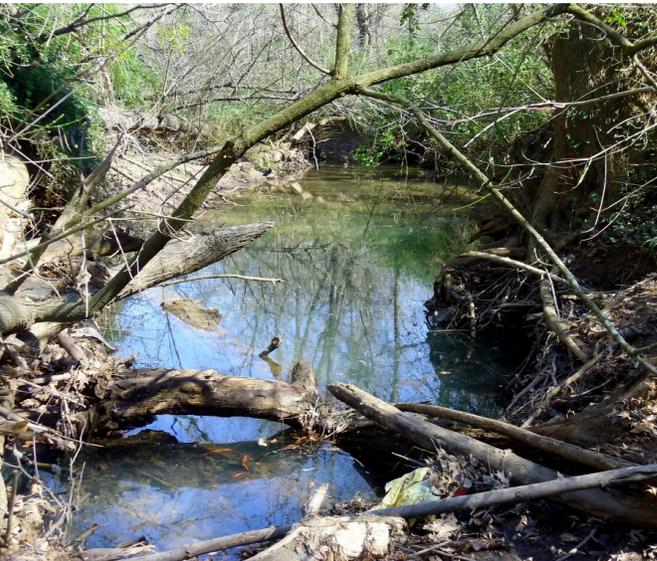
● PHOTO 1: Lilly Branch suffers from lack of riparian buffers.

Lilly Branch has a shallow dry-weather depth in most areas. It finally deepens to over 5 feet (1.5 meters) towards its confluence with the North Oconee River.² The riparian buffers along the stream are narrow or nonexistent and are therefore not effective at slowing runoff and capturing pollutants from the impervious surfaces in the watershed. In both the day-lit and piped reaches, storm drains run directly into Lilly Branch. Because of the resulting extreme wet-weather increases in flow, bank erosion, bank instability, and sediment-loading plague the day-lit portions of Lilly Branch.

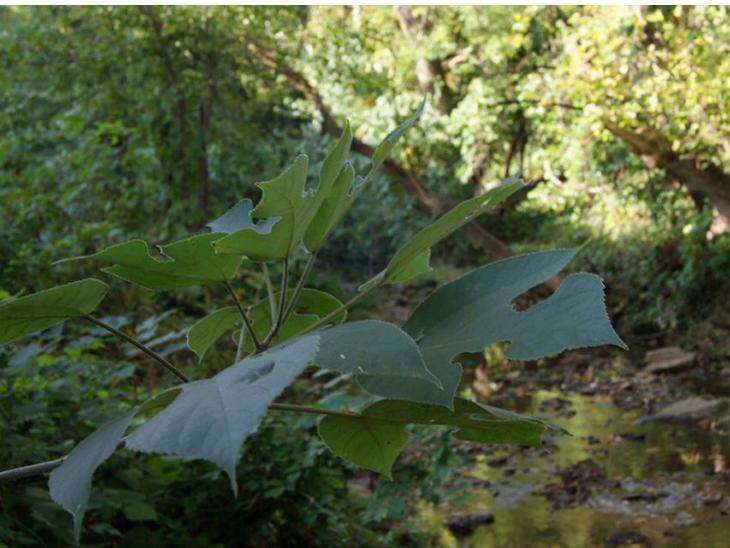
● PHOTO 2: Around 50 percent of Tanyard runs through pipes.

Approximately 50% of Tanyard Creek runs through culverts and pipes. Additionally, the bed of Tanyard Creek has been greatly affected by urbanization. Anthropogenic influences and land use changes have modified the substrate material. Litter, riprap, stones, manmade gravel, asphalt, and sand from the roads and parking lots that border much of the day lit segments are present in the channel.⁶ In February 2010, stream walks were conducted in the Tanyard Creek watershed by staff with the ACC Stormwater Management Program, who rated Tanyard Creek's overall

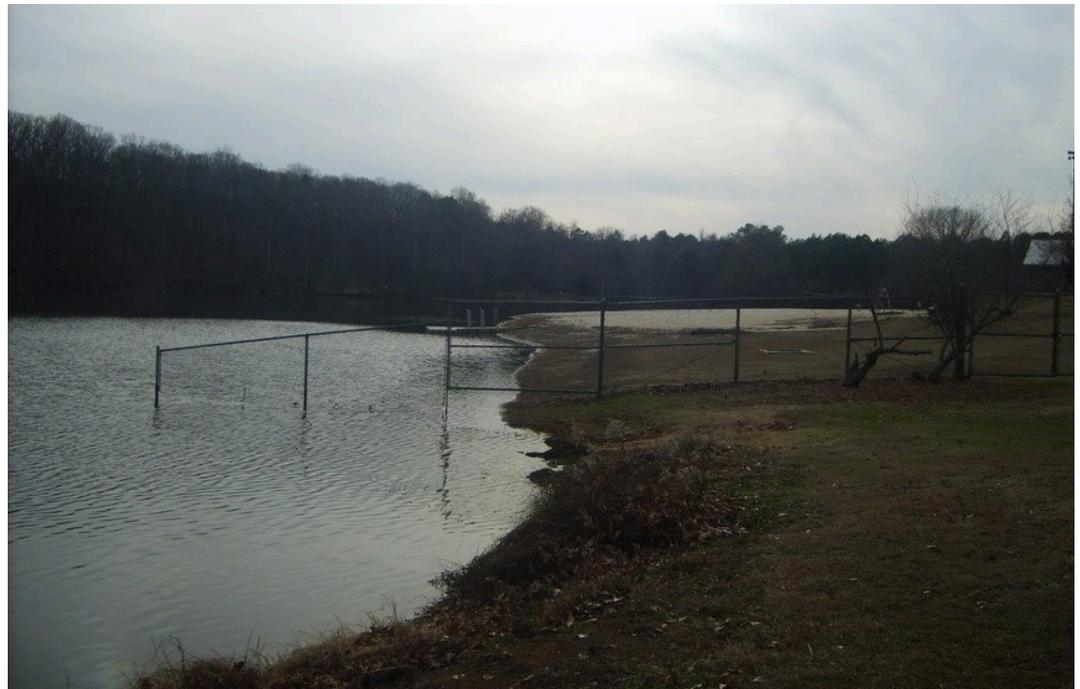
● **PHOTO 3:** *In 2002, swimming and boating were banned on Lake Herrick following a period of declining water quality and various management problems.*

Upstream of the lake is a tributary pond which drains a 66.4 acre subwatershed. The Oconee Forest Park Pond, has been nicknamed, "parvo pond" in reference to canine parvovirus, a highly contagious pathogen spread between dogs via fecal contact. Although both Lake Herrick and the Oconee Forest Park Pond have elevated levels of sediment, bacteria and nutrients, water quality conditions are consistently worse in the pond. Contaminant inputs are attributed to general nonpoint source pollution from domestic pets (given the presence of a popular dog park adjacent to the Oconee Forest Park Pond), urban stormwater runoff, erosion and sedimentation within the watershed and bacteria inputs from both wildlife (Canada geese).

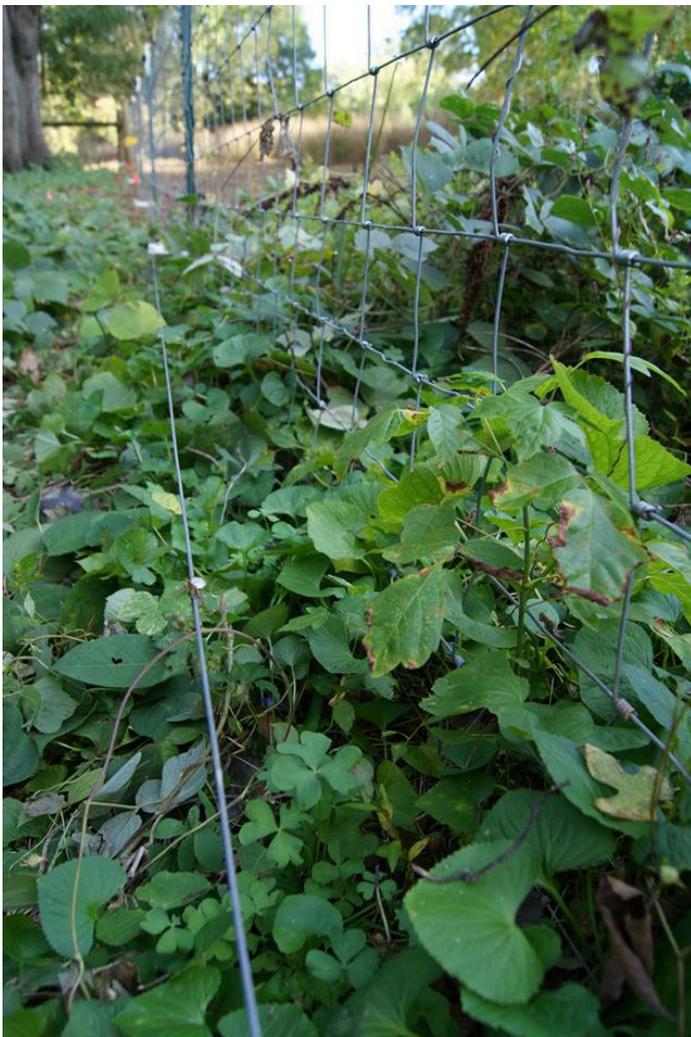
● PHOTO 4: *Invasives species alongside a fence at Tanyard Creek.*

Chinese privet, periwinkle, bush honeysuckle, Oregon grape, kudzu, Japanese honeysuckle, and Carolina geranium are the major invasive species identified by the Spring 2012 Environmental Practicum Class at UGA. That class's report on invasive species is attached as Appendix C. Chinese privet was singled out as an especially problematic invasive, as it grows abundantly on most of the Campus Watershed's stream banks.

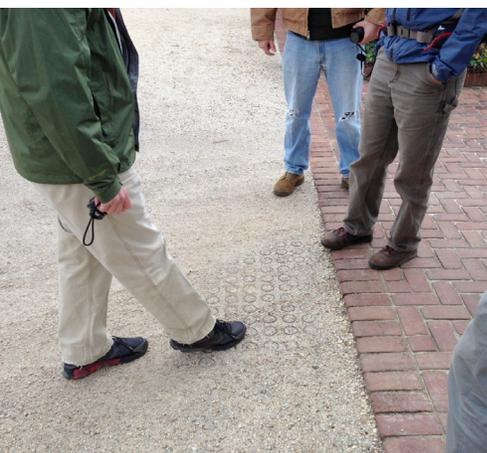
● **PHOTO 5.** UGA faculty and students examine an example of pervious parking in the watershed.

PERVIOUS PAVEMENT includes pores in the surface that allow water to collect in underlying storage areas, and then either infiltrate the soil directly or release slowly to an underdrain system. They are most appropriate for areas with low vehicular traffic volume, such as sidewalks, patios, residential park-

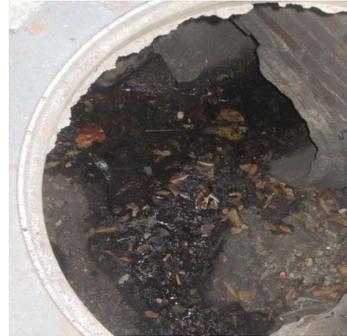
PHOTO 6B. Flow in dry weather in a stormwater pipe suggests sewage leak.

In an attempt to identify the source of the high levels of fecal coliform at the headwaters of Lilly Branch disclosed through targeted sampling, the Advisory Committee walked the stream in Fall 2012. They found a smelly, dry weather flow in one of the storm drains and alerted the ACC Public Utilities Department which investigated with dye and remote vehicles and identified two leaks. The department shut down Broad Street for several hours in order to repair a leaking sewer line underneath one of the buildings and another under Broad Street.

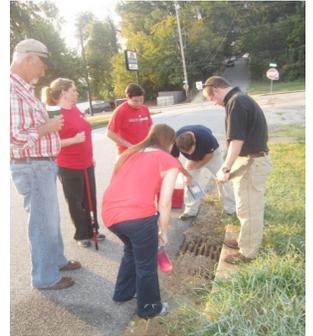
PHOTO 6C. Looking into stormwater system for flow.

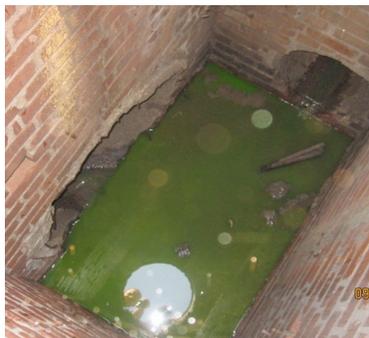
PHOTO 6D. Green dye is flushed down the toilet of a nearby business, helping hone exact location of leak.

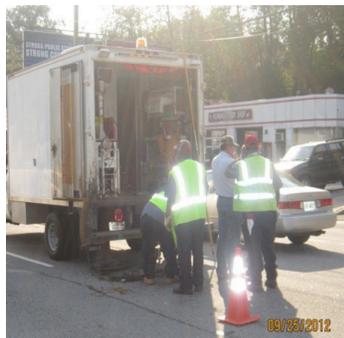
PHOTO 6E. ACC Stormwater workers repair the leaks.

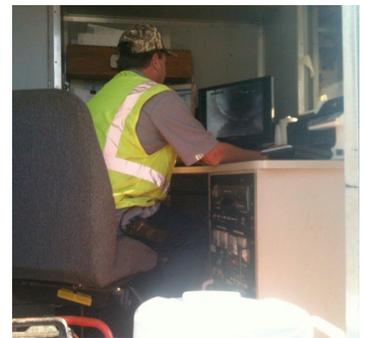
PHOTO 6F. ACC Stormwater worker uses a camera to find the exact location and extent of the two damaged sewage pipes.

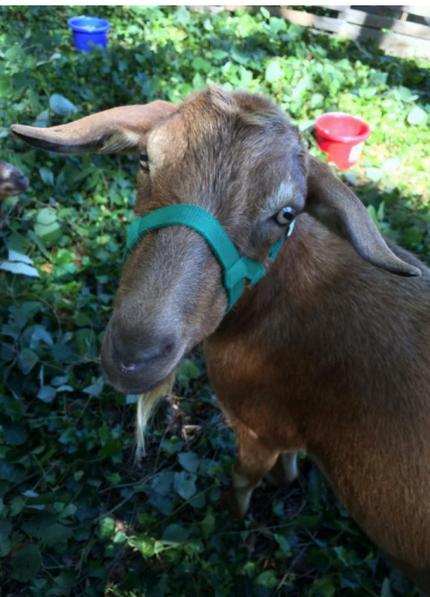
● PHOTO 7. A Chew Crew goat with some invasive species at Tanyard.

Goats were first used as a part of a student sustainability grant in the Tanyard Creek Watershed in Spring 2012. For six weeks, the “UGA Chew Crew” munched their way through invasive plant species such as Chinese privet and English ivy. They were back on campus in Spring 2013 and 2014. With help from a Ford College Community Challenge Grant, the Chew Crew is expected to expand to the Driftmier Woods in Spring 2015. These prescribed grazing projects have attracted the attention of the community and engaged numerous UGA courses from multiple departments.
